A-Team

Inspection Report

Inspection Address: XXXXXXXX
XXXXX, XX XXXXX

Date of Inspection: 27 XXX 12: in @ 11:50 AM, out @ 2:10 PM

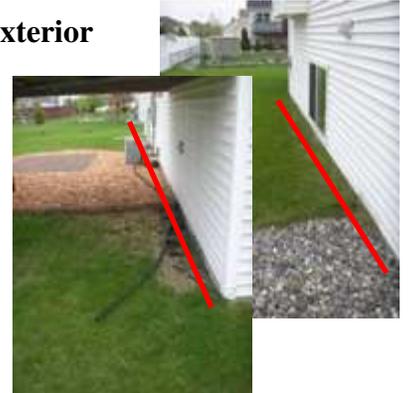
Grade/drainage

Foundation fill is needed around the perimeter of the home to assist in directing water away from the foundation. This will require the rocks to be removed, dirt applied and to slope away from the foundation. The rocks can then be replaced over the new layer of fill. See additional comments on this subject in the "Overhang/gutters" line below.

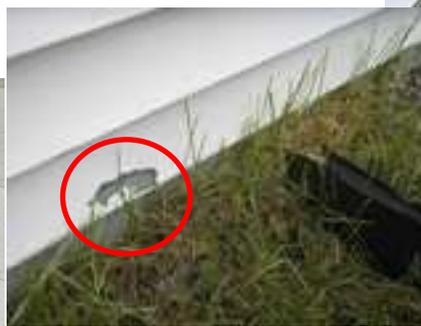
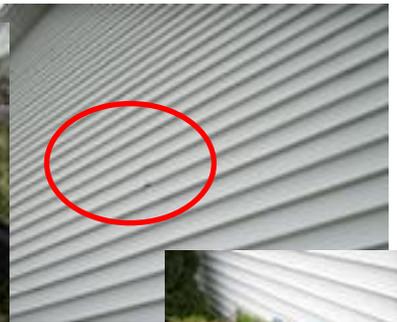
Wall covering

The vinyl siding has minor damage to the west side. The upper level damage may relate to hail. The lower board damage is most likely related to a "weed-wacker" hitting the siding. There is stain spilled on the vinyl siding under the deck. The siding is dirty in the dog kennel area, but although difficult to see, there does not appear to be any damage to the siding in this area. The exterior

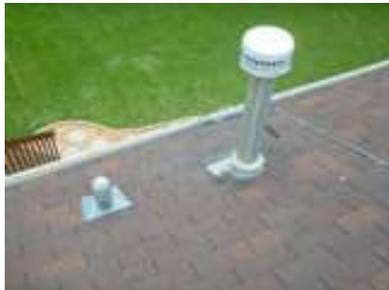
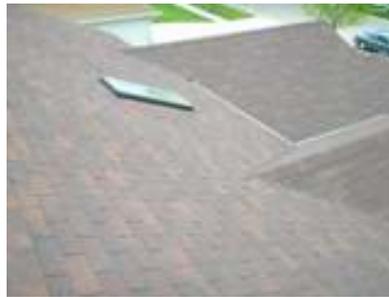
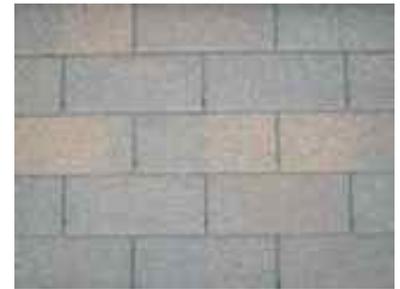
Roof covering/vents

There is what appears to be hail damage to three plastic roof vent covers. At the client's request, the inspector applied a brown duct tape over the holes and cracks in the roof vents to keep rain from falling through the large holes in one roof vent. Normally when hail has damaged the roof vents in this manner, there is some damage to the shingles. The inspector was not able to see any significant damage that may have related to the September 2007 hail storm that hit this area. The defective classification relates to the damaged roof vents only.

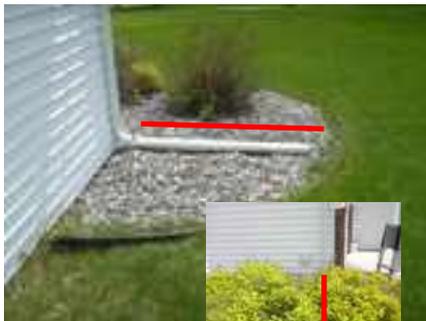
Overhang/gutters

The inspector recommends the rain gutter downspout extensions discharge outside of landscaping areas. The rain gutters are bent in a few areas, but this does not appear to relate to hail. The SW downspout extension needs to have a greater slope to ensure water is flowing through the extension and away from the home. The inspector also recommends the downspout west of the front entry discharge further from the home. The inspector also recommends a short 6-8 inch downspout extension replace the 4 foot extension in the SW corner of the garage and the water be directed south onto the driveway. This downspout in this corner of the garage and will most likely never be lowered over the sidewalk and

therefore it is recommended the discharge direction be changed and the 4 foot extension be removed.

- Remove the current 4' extension being stored in the “up” position and install a short 6-8 inch downspout extension in the SW corner of the garage and discharge the water to the south onto the driveway.
- Level the air conditioner compressor.
- Change the batteries in the smoke detectors and install a carbon monoxide detector in the home.
- Service the furnace prior to the start of the next heating season.
- Install door stops where needed.

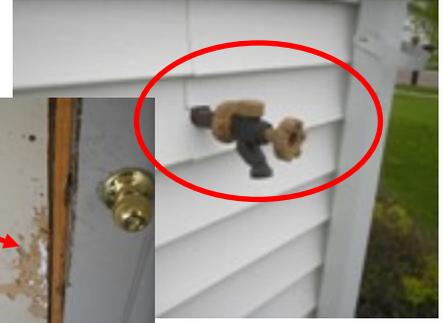
There is an exterior faucet on the west side of the home that is not fastened to the wall.

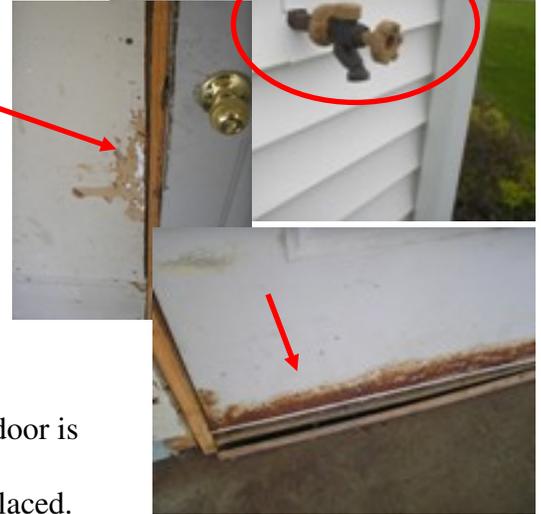
There is dog damage to the drywall in the area of the rear garage walk-in door.

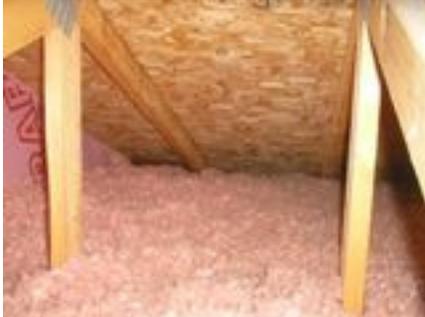
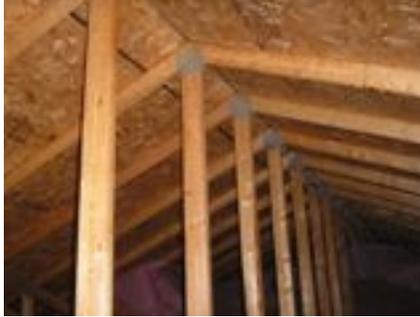
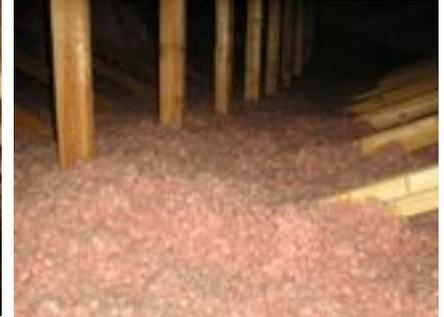
Attic

There is ~18” of insulation in the attic. The soffit vent shoots are clear of insulation. One roof vent has large holes and two others are cracked. These roof vents will need to be repaired or replaced.

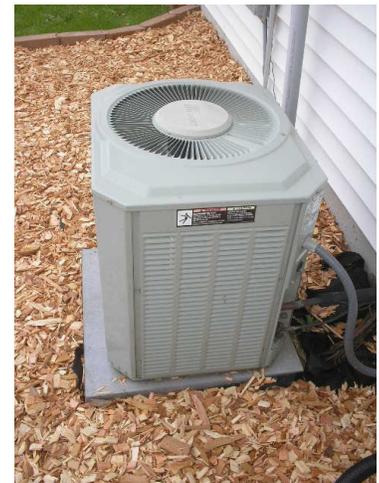
The inspector estimates the compressor was manufactured in March 1999. The compressor needs to be leveled for improved efficiency.

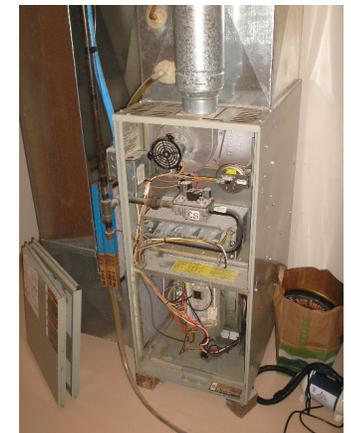
The furnace produced a hot air temperature of 110° - normal temperature for this type of system.

There was no service sticker on the furnace. Natural gas furnaces should be serviced every 2-3 years and therefore the inspector recommends the natural gas furnace be serviced prior to the start of the next heating season.

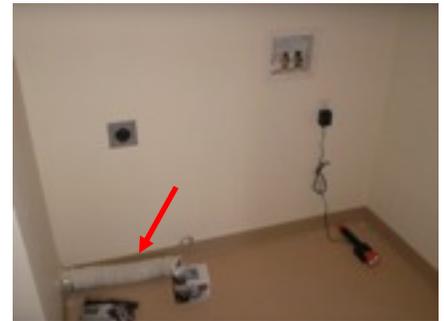
Laundry fixtures The inspector recommends the vinyl clothes dryer discharge hose be discarded and replaced with the newer and safer aluminum dryer vent hose.

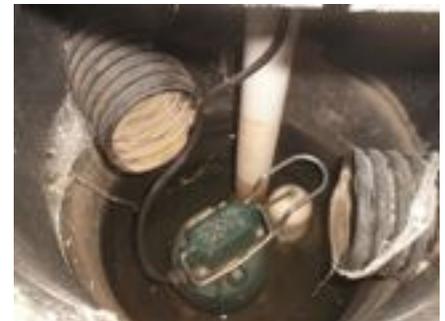
Sump pump The sump pump was manually activated and it pumped water. It is important the discharge hose discharge at least 15-20 feet from the home's foundation.

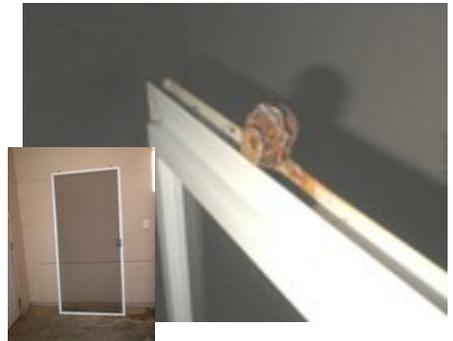
The roller guides for the patio screen door are damaged and the screen door is located in the garage. The screen door frame appears to be functional, but the roller guides will need to be replaced.

The exterior patio door light bulb is most likely burnt out. There is no overhead light in the living room, but there are switched-outlets in this area.

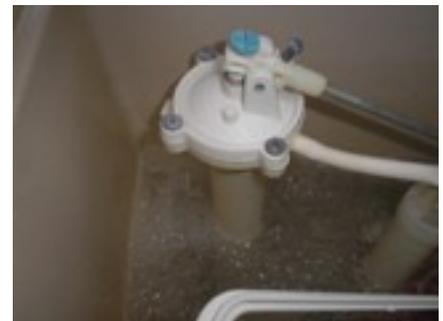
The master bathroom bathtub/shower faucet drips for an extended period of time after the valve is turned off. The other bathtub faucets stop dripping rather quickly, but this faucet does not. The seal is leaking in the upper level main bathroom toilet flush mechanism. This flush mechanism needs to be changed before water starts spraying up against the tank cover and water starts dripping behind the toilet.

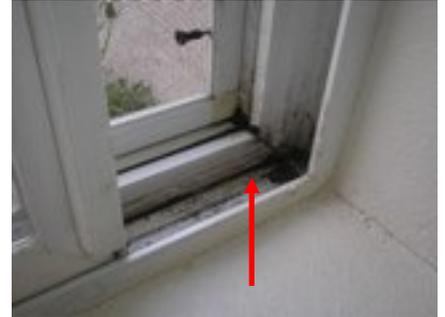
The lower level SE bedroom entry door latch needs adjusting to catch. The lower level NE bedroom door knob needs its setscrew tightened. The lower level sliding window tracks need to be cleaned to allow the windows to slide open and closed easily. The upper level north bedroom inner wooden window ledge is in need of surface preservative maintenance.
